Massachusetts Water Resources Authority
Remote Headworks Upgrade Design and Construction
Administration Services, MWRA Contract No. 7206

Risk Based Disposal Plan – Chelsea Creek Headworks

Final Hazardous Building Materials Evaluation

March 2011

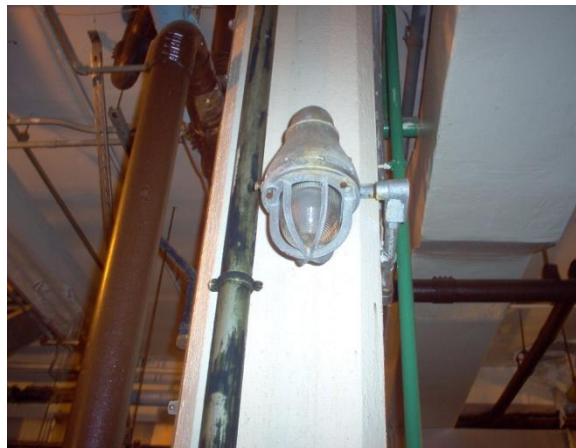
White column and ceiling paint at Chelsea Facility

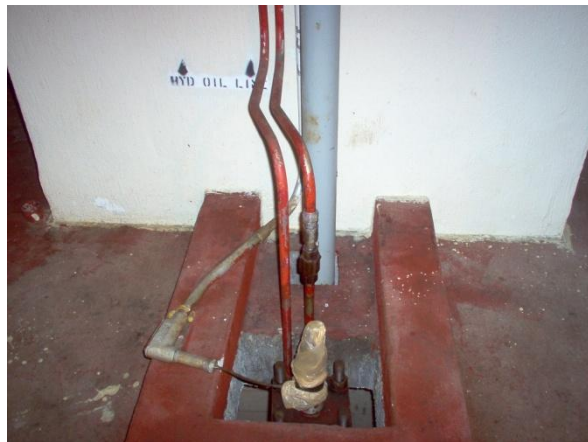
Red floor paint in Chelsea Facility

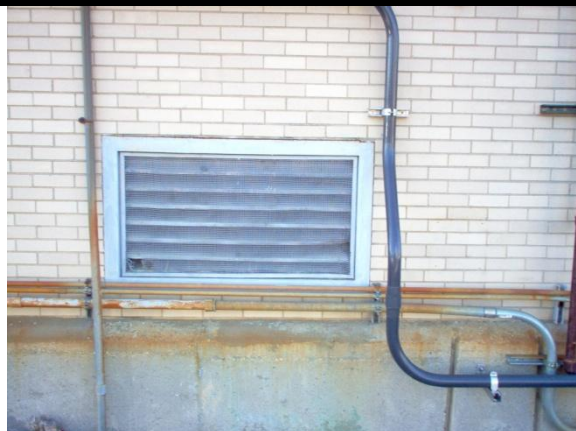
In general, most of the subject paints were pervasive throughout the building, and in generally poor condition. PCB caulk located on the exterior of the building is in a degraded state from weathering.

PCB Caulk around louvers Chelsea Facility

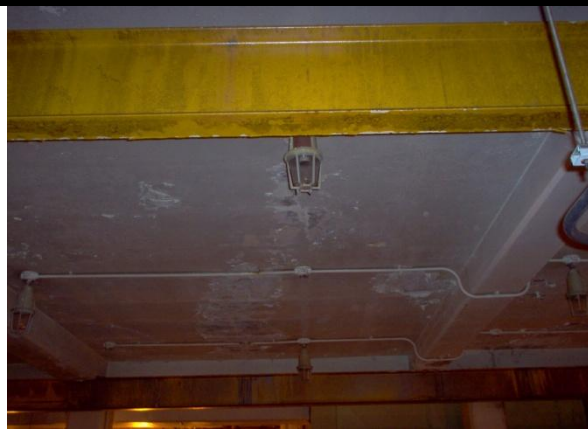
Damaged white ceiling paint Level -1 Mezzanine Chelsea Facility

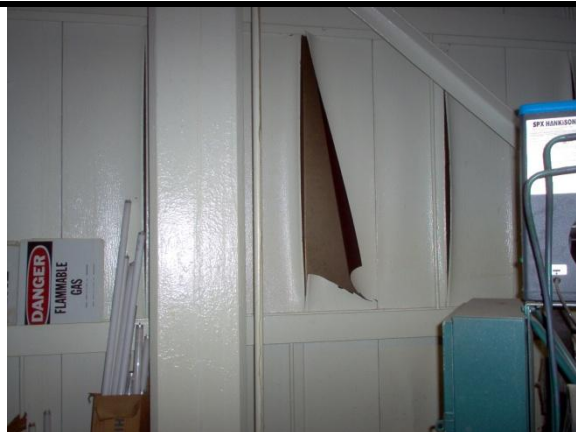
White PCB wall paint covering asbestos tarpaper 2nd level of Chelsea Facility

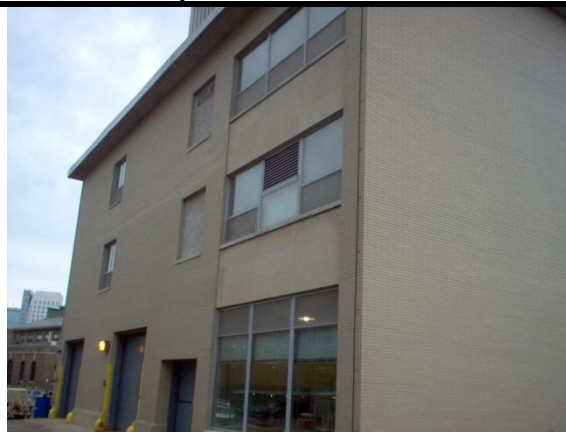
PCB containing Blue Garage Doors Backside of Ward St.

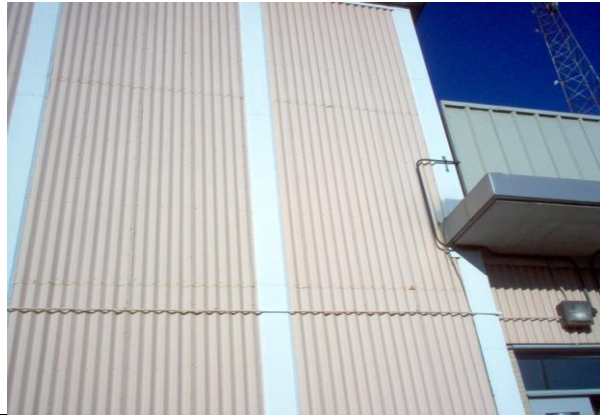
Asbestos exterior siding with asbestos caulk Between panels at Chelsea Creek Facility

All of these materials will require removal and disposal in compliance with applicable regulations during renovations.

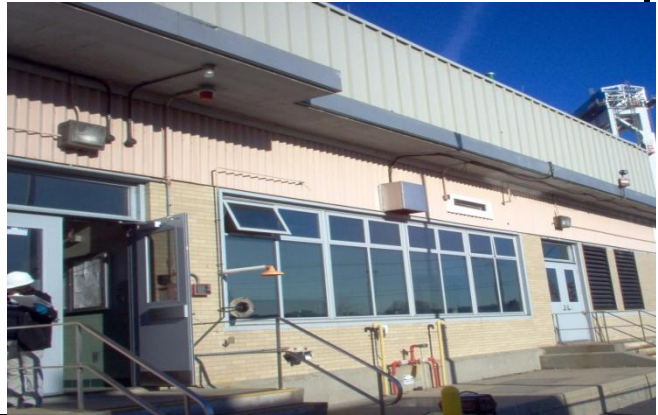
Asbestos Containing Exterior window and door caulking locations at Chelsea Creek Facility

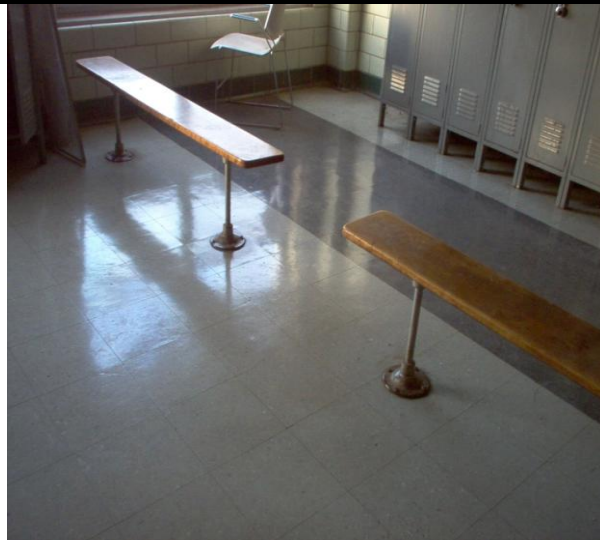
Exterior containing mastic under floor in the 2nd Floor Locker Room at Chelsea Creek

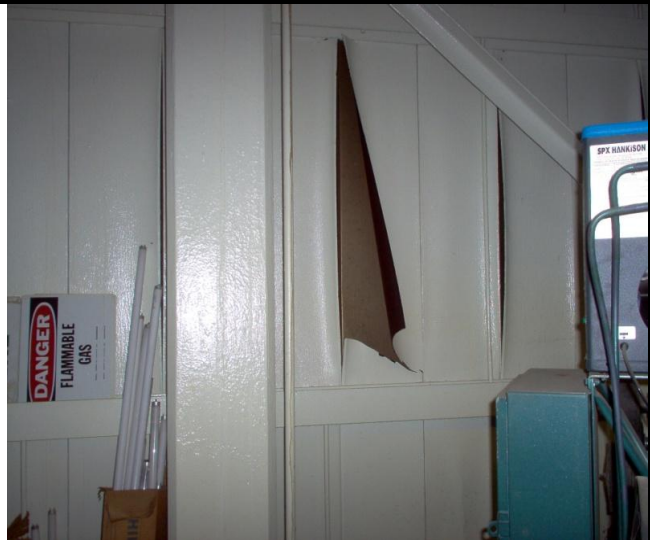
Tarpaper on walls in the 2nd and 3rd Levels of the building at Chelsea Creek.

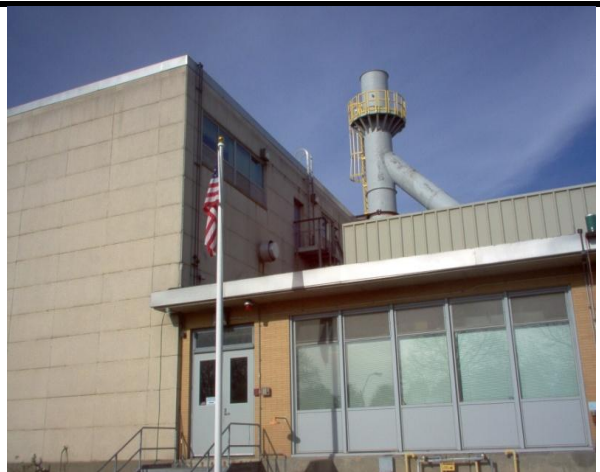
Overview of asbestos caulk on cement panels on exterior at Columbus Park

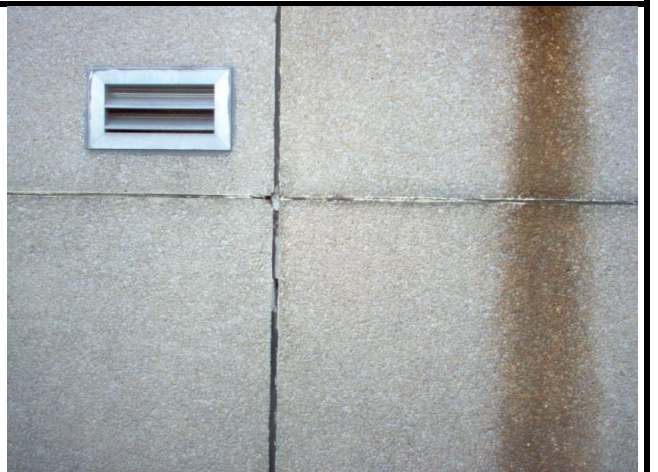
Close up of asbestos caulk in between cement panels

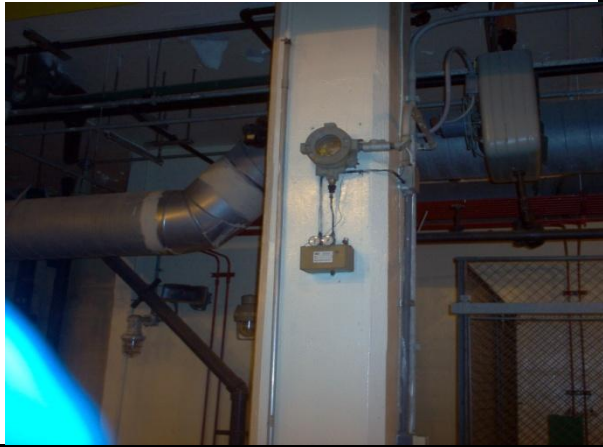
Mercury containing switches at all three sites.

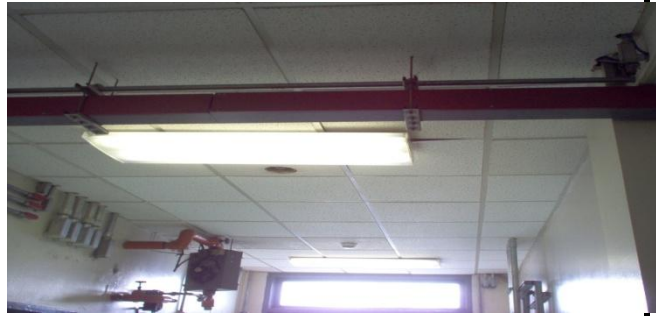
Mercury containing bulbs in all three sites.

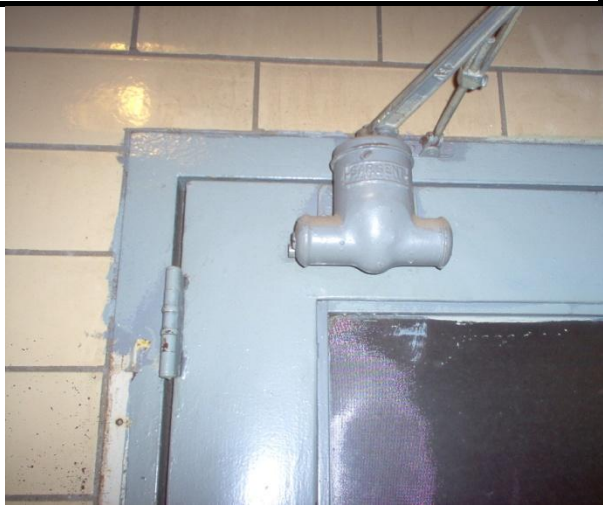
Door pistons – possible PCB contaminants.

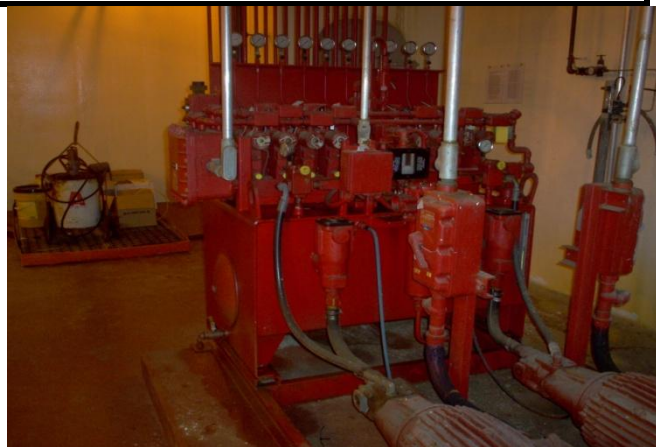
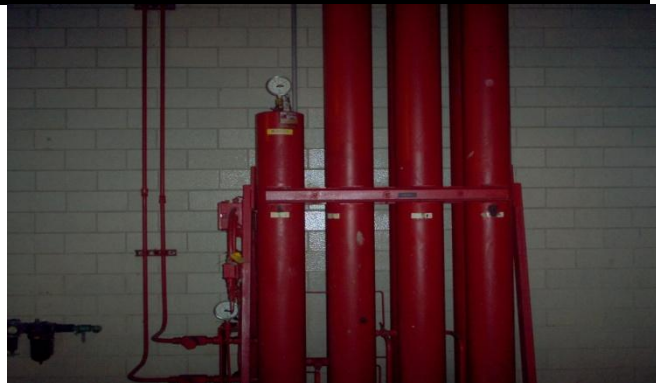
Hydraulic Oil/Motor Oil: Throughout all buildings various containers and drums of hydraulic and motor oil were observed. All observed containers were either on spill pads or within contained areas to collect spilled oil. Hydraulic pistons were observed in lower levels of all facilities. All of these items would need to be drained and disposed of in accordance with State and Federal Regulations. A review of the MSDS sheets for the facility indicated that Hydraulic oil is Fleetline A W32. Upon speaking with plant personnel, it was determined that fluid is routinely replaced as part of a regular maintenance schedule. See photos in Appendix A for examples.

Hydraulic Oil and Fluids at all three sites.

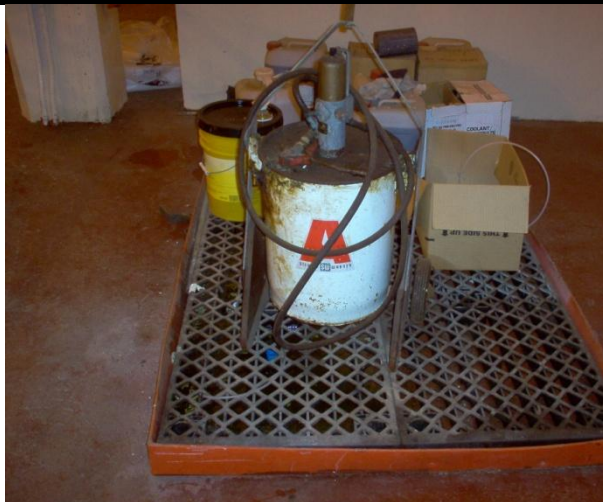
Oils on spill pads at all three sites.
